# Manhole Inspection Summary

Manhole # S350\_\_014MH

Insp Date: **1/24/08 9:23 AM**

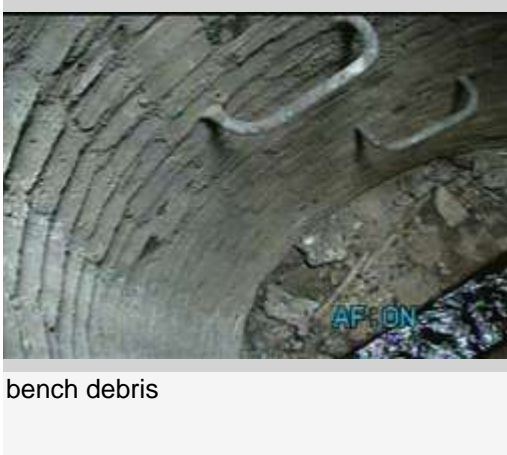
Defect 2

Condition: ☐ Sound ☐ Cracked ☐ Root Intrusion ☐ Deteriorated ☐ Leaks ☒ **Debris**

bench debris

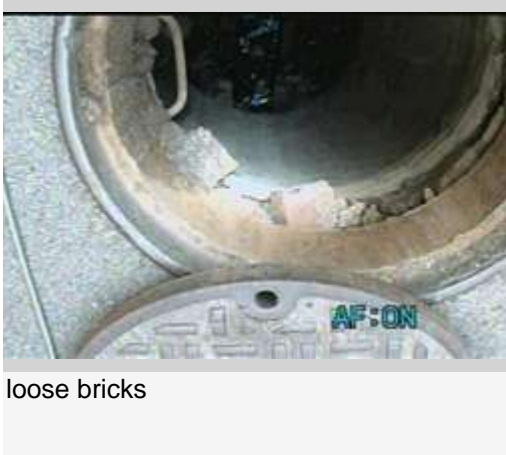
Defect 1

Condition: ☐ Sound ☐ Cracked ☐ Root Intrusion ☒ **Loose Brick** ☐ Deteriorated

loose bricks

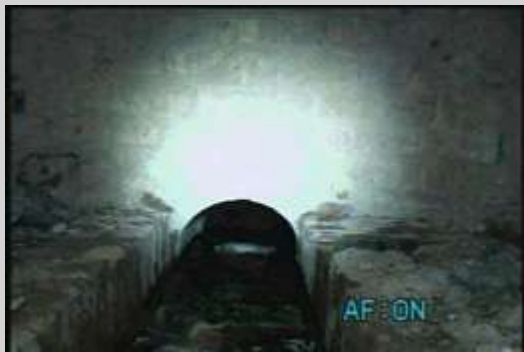
12 O'Clock Outflow

8 in. Circular Gravity Sewer  
Pipe Out @ 12 O'Clock

Invert Depth: **8.20** (ft.) Flow Characteristics: **Slow**

Infiltration: **None** Pipe Seal Cond: **Unknown**

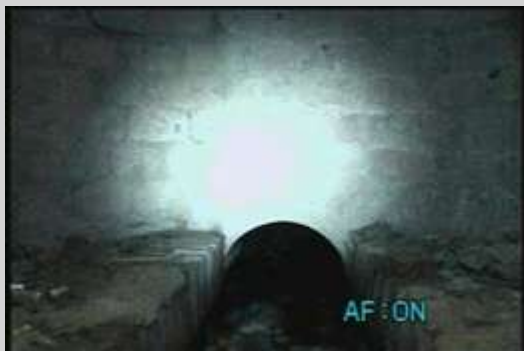
6 O'Clock Inflow

8 in. Circular Gravity Sewer  
Pipe In @ 6 O'Clock

Invert Depth: **8.10** (ft.) Flow Characteristics: **Slow**

Infiltration: **None** Pipe Seal Cond: **Unknown**
